“Integration of sensing and modelling technologies for early detection and follow-up of hazmat and flood hazards in transitional and coastal waters”

Feedback on past incidents in transitional waters

WP	4, Task 4.2.1
Action	Report – Feedback from past incidents
last updated	11 /02 / 2020
version	Final
authors	Cedre
participants	All

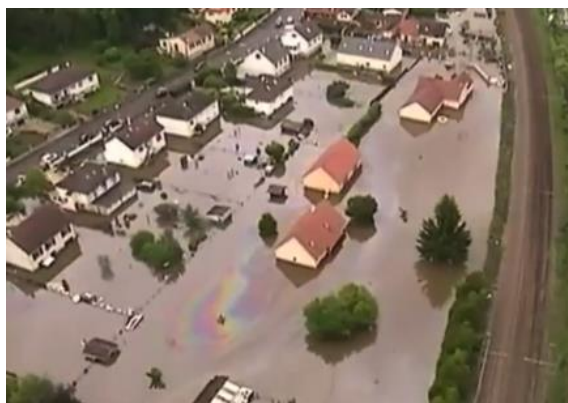
Photo 1 Diffuse light oil contamination in flooded city of Nemours (source France2)

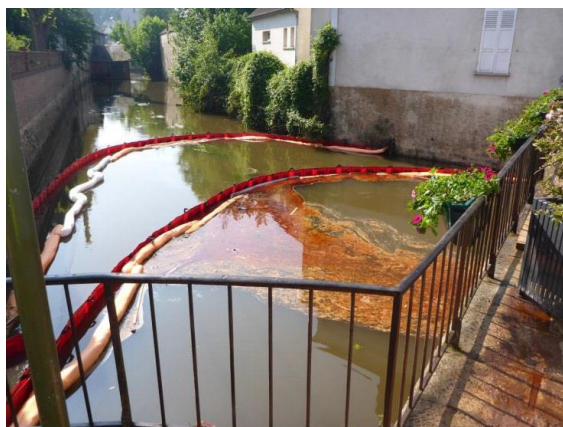
Photo 2 Containment of home heating oil escaped from private flooded cellars, by floating and sorbent booms (source Cedre)

The pollution had spread very widely, carried by the flood waters as the water levels rose then fell. Helicopter overflights were conducted to monitor its spread along the watercourse, observe the containment systems deployed (floating booms) and recommend adjustments to optimise the set-up of these booms (photos 2 and 3).

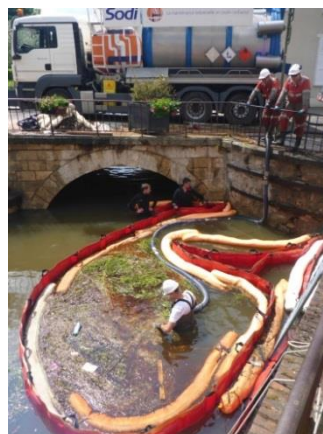
Photo 3 Containment and pumping with vacuum truck on the river Loing in an old city center (source Cedre)

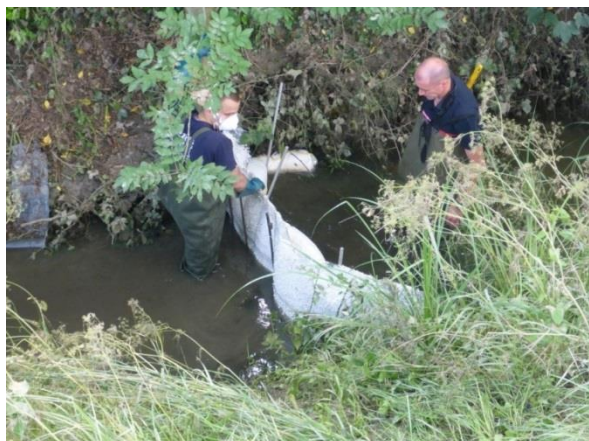
Photo 4 Custom-made barriers and filter systems for polluted small streams (source Cedre)

Very soon, these investigations were further supported by surveys conducted on land, or even by boat when the streets were flooded. New recommendations on containment techniques and equipment were issued to support emergency response operations, in particular with advice on setting up custom-made barriers and filter systems, as classic booms were unsuitable for certain sites or configurations (photos 4 and 5).

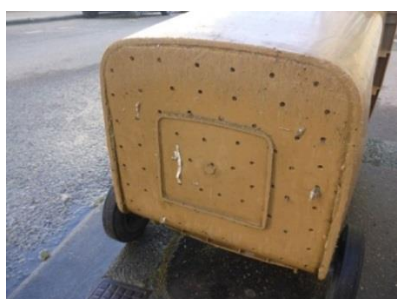
Photo 6 Custom-made filtration systems in a bin with a perforated base (source Cedre)

Another urgently needed action was to pump up the large volumes of contaminated water at flooded sites (cellars, underground car parks). Cedre assisted the Seine-et-Marne fire brigade in designing and building custom-made filtration systems (bins with a perforated base and filled with loose sorbent), in order to evacuate the water from these sites and release it into the natural environment (photos 6, 7, 8).

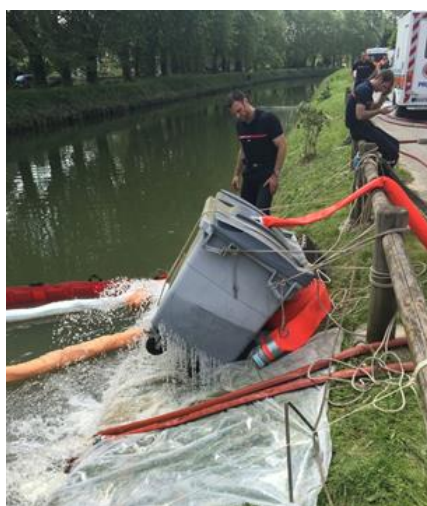
Photo 8 Firefighters using the system to evacuate and filter oily water from a private house cellar (source Cedre)

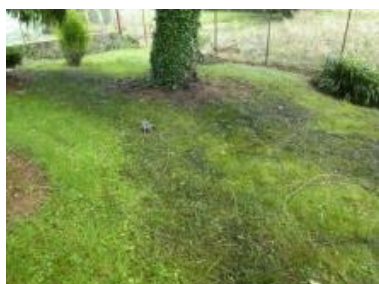
Photo 9 Engine used oil in garden (source Cedre)

The techniques recommended for gardens are similar to those used during the "botanical clean-up operations" implemented in oiled natural vegetated areas: scything, selective cutting, scraping, or even removal of a few centimeters of soil. In terms of the clean-up of hard surfaces, the emphasis was on the urgent need to contain, recover and treat washing effluents.

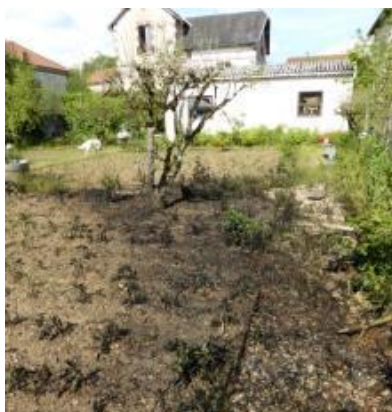
Photo 10 Used oil in a vegetable garden (source Cedre)

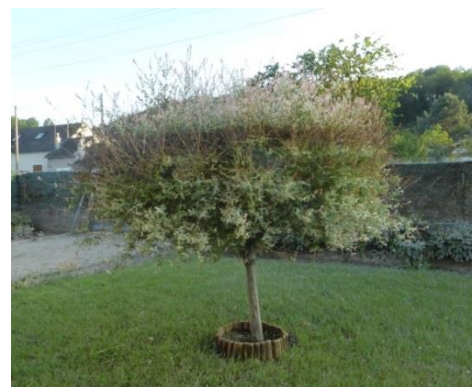
Photo 11 Oil level mark on a tree (source Cedre)

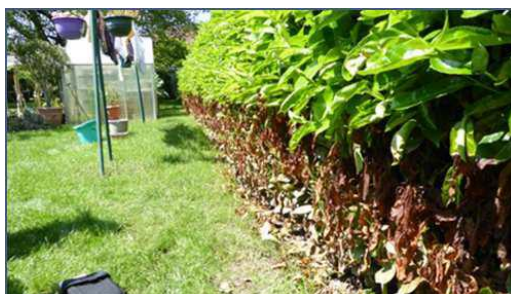
Photo 12 Vegetation burnt without trace of oil, possible effect of agrochemical products (source Cedre)

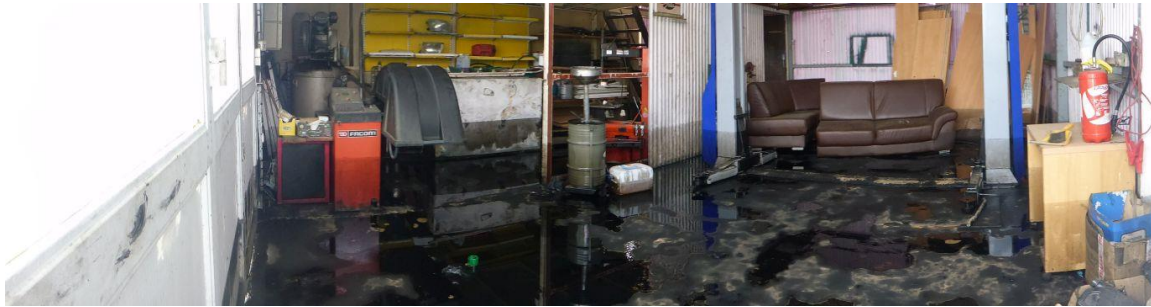
Photo 13 Used engine oil in a garage after flood water recede (source Cedre)

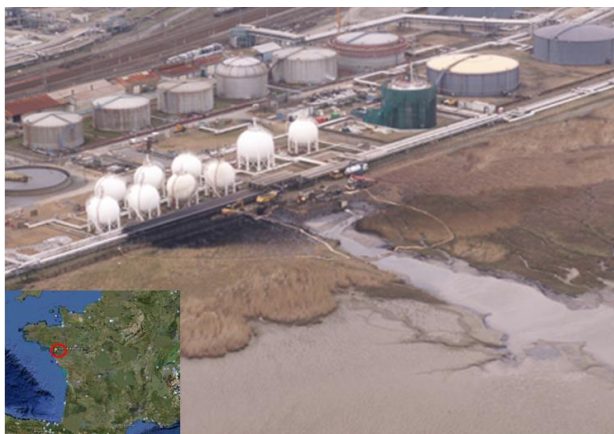
At the leakage point, the creek was heavily oiled (Photo 14) but during the first days, due to neap tides, mobile oil remained on water, on the lower part of the banks and mudflats (Photos 15, 16) while the upper part of the vegetated banks remained unoiled.

Photo 14 Location of the spill and view of the spill site just by the Loire estuary (Source Cedre)

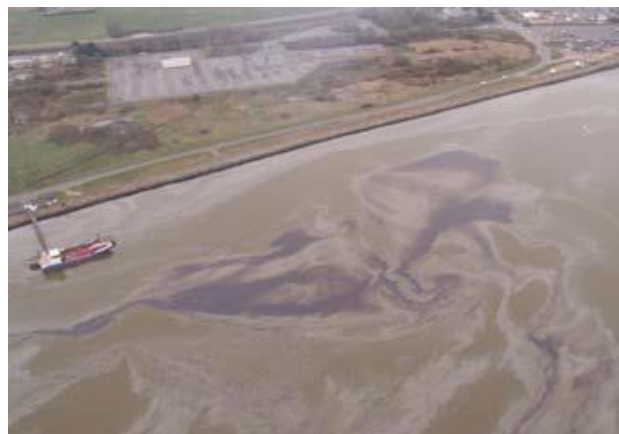
Photo 15 Slick on water on the 17th of March (source Cedre)

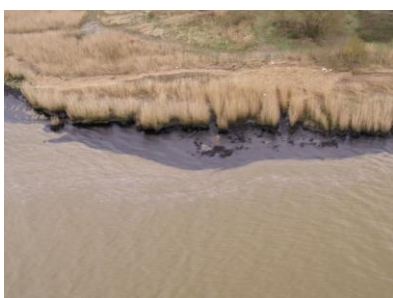
Photo 16 At first, oil remained at the lower part of banks (source Cedre)

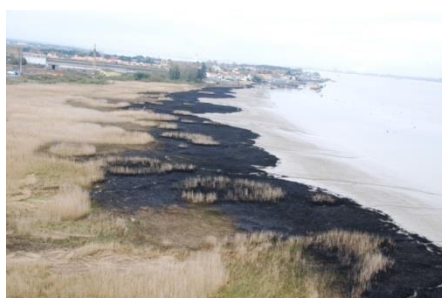
After few days, due to an increase in tide and in the river flow, a sudden spill-over occurred at high tide, and as a result, a large extension of contamination could be observed on banks. Oil penetrated into small creeks and overflowed spreading into wetlands and meadows where nearly 4 000 ha of meadow were submerged, 530 ha of which were heavily to moderately contaminated (Photos 17, 18).

Photo 17 Due to tide increasing, large areas of wetlands were oiled (source Cedre)

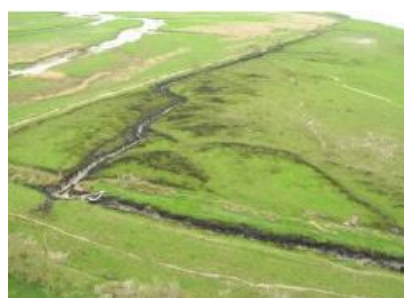
Photo 18 Oil penetrated deep inside small creeks (source Cedre)

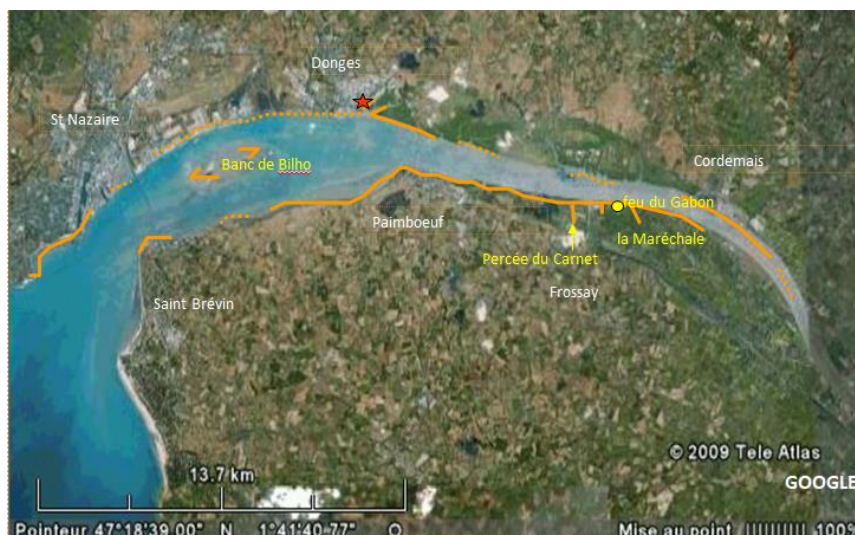
Inside the estuary, trajectories simulations prepared in advance were included in the Contingency Plan of GPMNSN (Harbour of Nantes-Saint-Nazaire). In fact at this time, at that time, the available hydrodynamic model requires, 3 days before getting results. These simulations indicated a potential drift to 30 km upstream which was in fact the extreme distance from the leakage observed after some days (Fig. 20).

Fig. 20 Maximum extension of the oil contamination in the estuary (source Cedre)

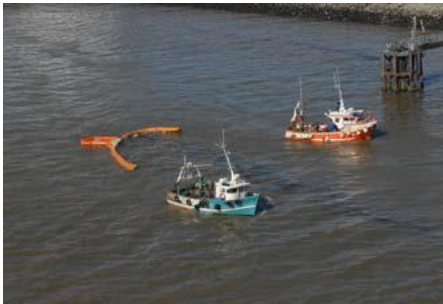
Photo 20 Trawling of the Thomsea by fishing vessels (source French Customs)

In order to recover the pollutant at the external part of the estuary and at sea, the *Argonaute* Support, Assistance and Clean-up vessel (BSAD) from the French Navy was mobilised and equipped with a *Thomsea* trawl net. Inside the estuary smaller fishing boats equipped with small *Thomsea* trawls filled with loose sorbent were mobilised. There were only one or two access points to the banks for pumping by tanker trucks.

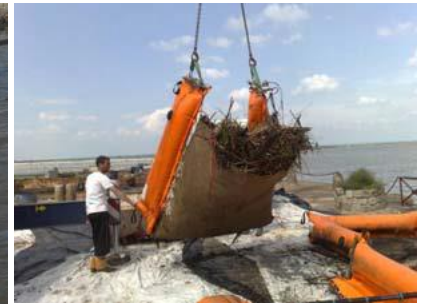
Photo 21 Craning a Thomsea trawl full of polluted floating reeds (source Thomsea)

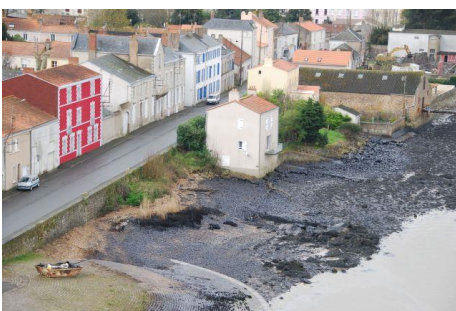
Photo 22 Oiled banks of blocks and rocks (source Cedre)

Onshore, the techniques implemented were classic: manual collection of accumulations, high-pressure cleaning of infrastructures (quays, wharves, rockfill), pebble/rock washing sites with concrete mixers, etc.

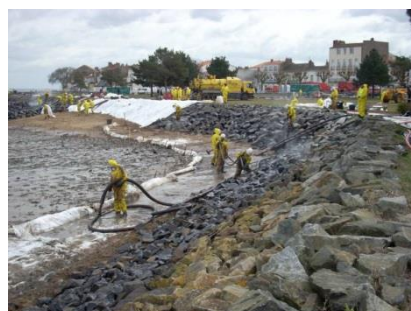
Photo 23 High pressure washing of rip rap (source Cedre)

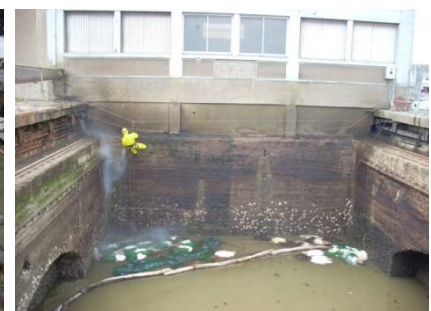
Photo 24 High pressure washing in port basin by a rope work specialist (source Cedre)

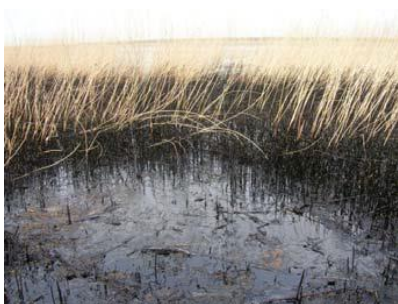
Photo 25 Heavily oiled common reed (source Cedre)

Large areas of vegetation were oiled and different types of vegetation impacted. Depending of the sensitivity of plants, contamination levels and accessibility, different clean-up techniques were applied: natural self cleanup (schorres and bulrush reed beds with very loose soil and light oiling), trapping of pollutant by net, manual cutting or mowing of heavily oiled reed beds using light equipment (such as brush cutters). In an area with sufficiently load-bearing soil, mechanical surface scraping using a mechanical shovel (which is normally banned in these types of habitats) was used, taking care to limit the impact on rhizomes. This delicate operation was carried out thanks to the shovel operator's know-how, which prevented the machine from sinking (in some places, the use of tread plates was necessary) and adjusted the scraping to the polluted layer (photos 25, 26, 27).

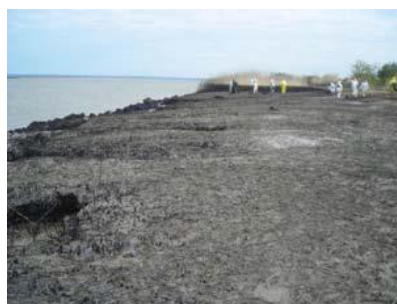
Photo 26 River banks just after cutting of common reed and sediment surface scraping (source Cedre)

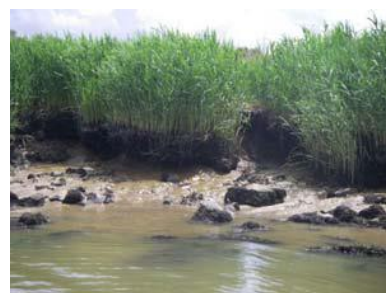
Photo 27 Complete regrowth of common reed after three months (source Cedre)

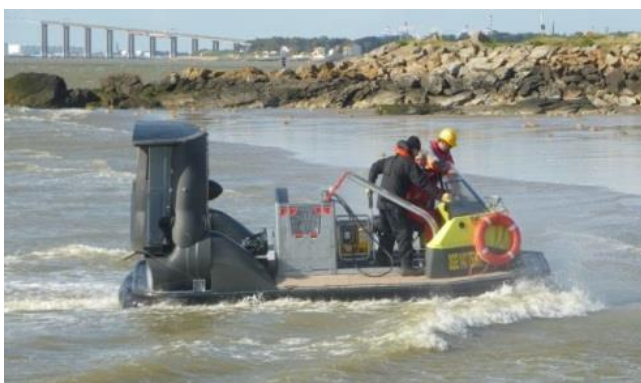
Photo 28 Prototype of hovercraft for operations on mudflats and in shallow waters ("Hoverspill" CE project, 2009-2013) (source Cedre)

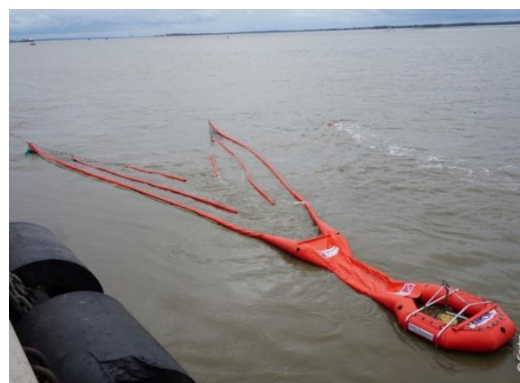
Photo 29 Trial in Loire estuary of a floating hydrocarbon containment and collection system for fast current-LMOS Sweeper system- (source Cedre)
