Key lessons from past incidents 2008 Loire estuary contamination

CEDRE

Workshop Saint-Nazaire

A medium spill in Loire estuary (France)

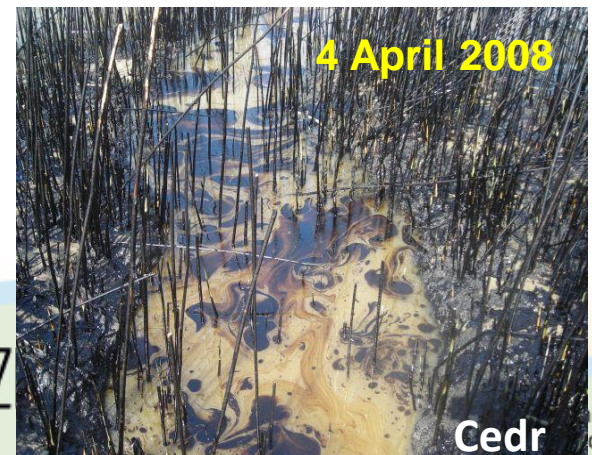
- **Sunday 16 March 2008 in the Loire estuary at low tide (neap tide coeff. 39), river flow 1000m³/s**
 - 16h 20 : oil reported in the river, close to the ship loading wharf,
 - 30 minutes after, leakage from a pipe was identified and stopped, emergency plan and crisis activated, firefighters and experts mobilised
- **In the overnight**
 - with the rising tide oil slicks and sheen already spread from 10 km upstream to the external part of the estuary at sea,
 - Some oil was already ashore, mostly on the south bank due to wind from the North
- **The spill**
 - 500 tons inside the refinery site,
 - **~ 200 t in the estuary**
 - Intermediate fuel oil (IFO 380) (viscosity)
 - Emulsification after few days

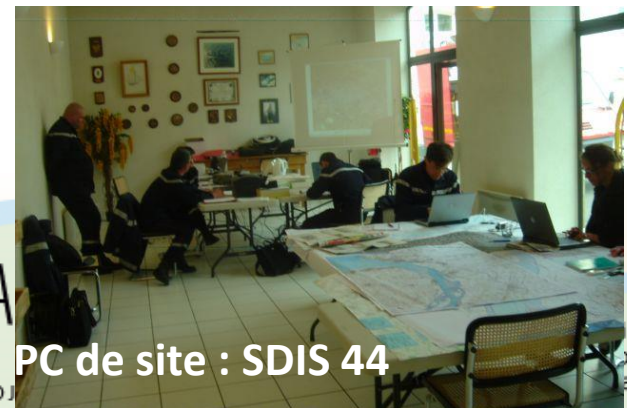
PC de site : SDIS 44

- A crisis unit at the Departmental prefecture (Centre Opérationnel Départemental - COD)
- A Command Post (PC) at the refinery (north bank)
- A comand post at Paimboeuf municipality (south bank) under SDIS command with representatives of the oil company, and Cedre experts
- The oil company took the lead for the response operations under the control of Prefecture represented on site by Cedre and SDIS 44
- An enviromental expert group is activated by the environmental administration (DIREN)
- An expert group is set for the follow up of pastures of the Loire flooded plain
- Daily assesement of the pollution extension by helicopter, boat, walking
Gendarmerie, Civil Security, Oil company, SDIS44, Cedre

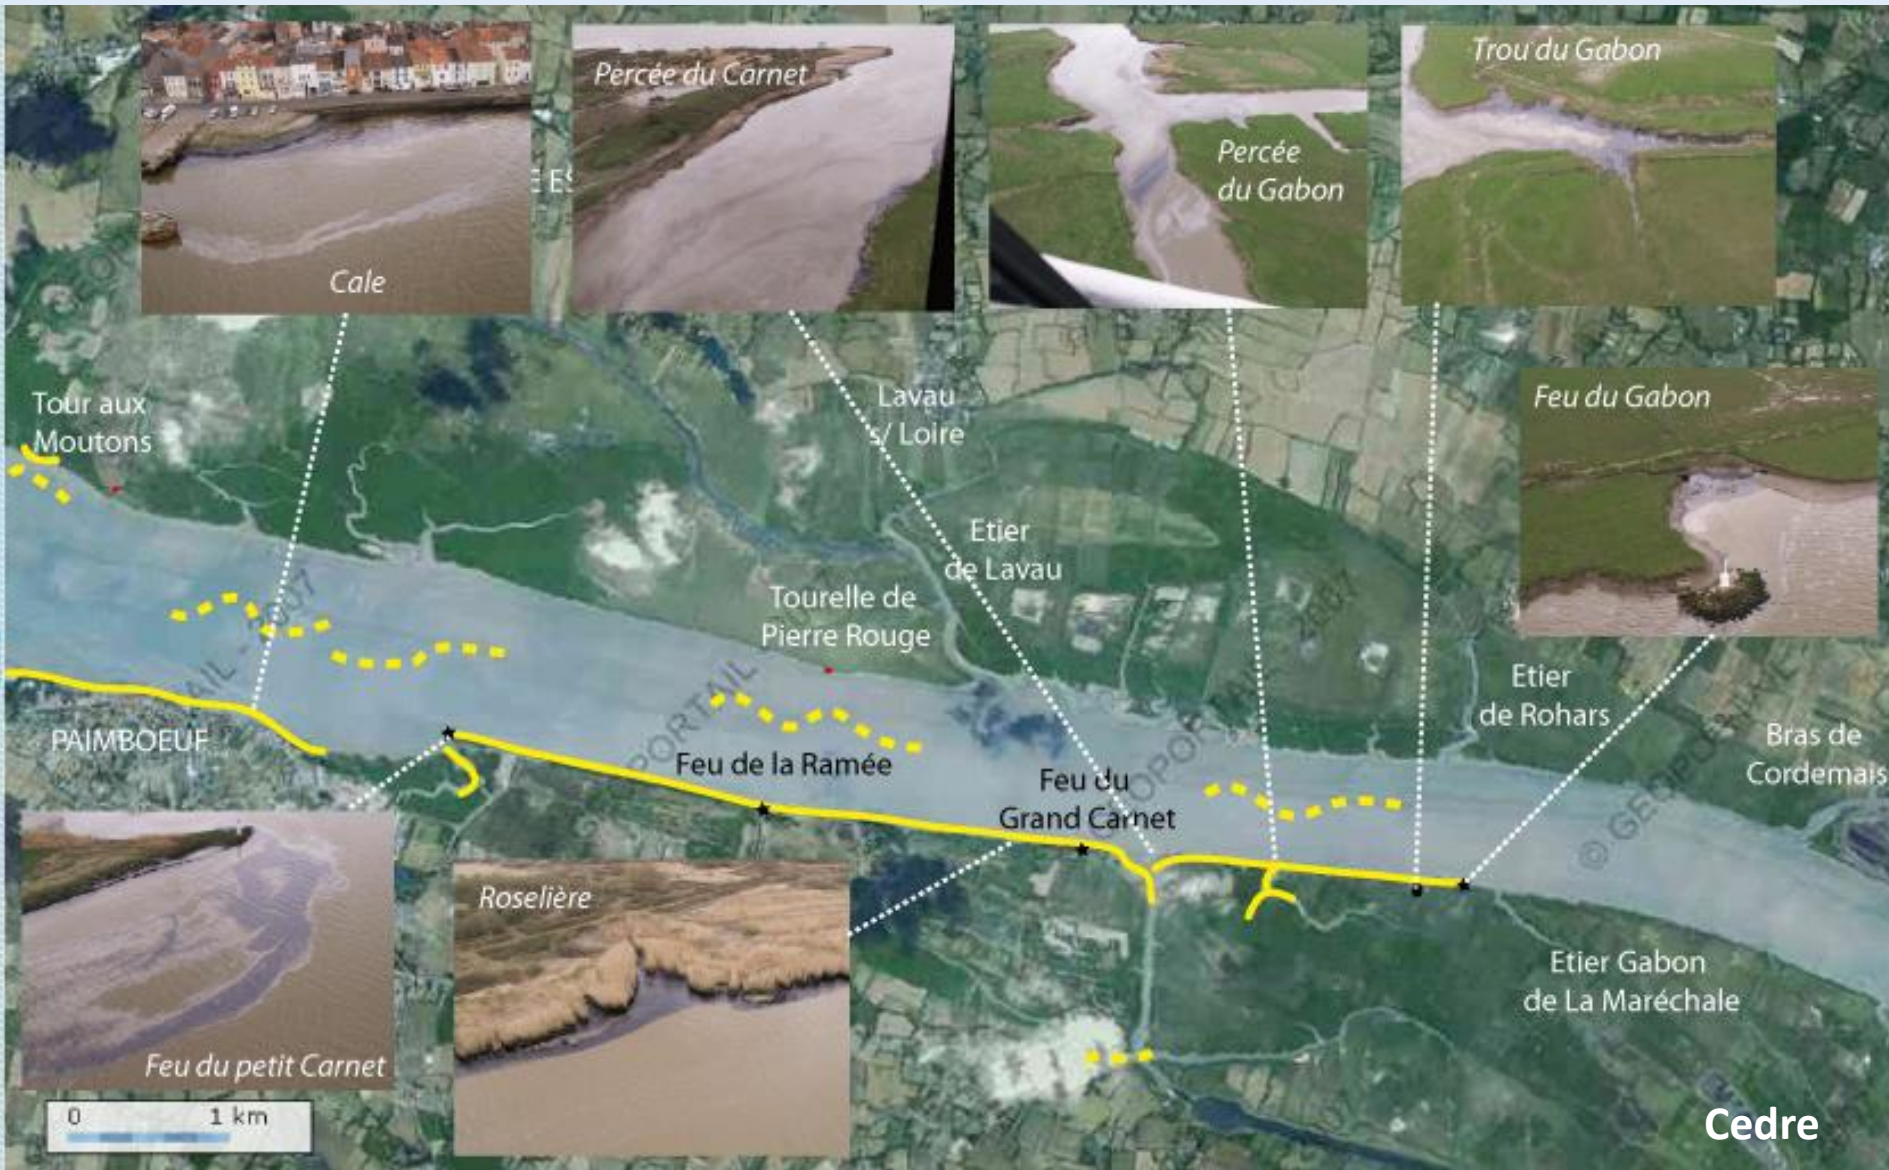
**Bilan de la reconnaissance aérienne SDIS 44
Mardi 25 mars 2008 à 15h00**

Map and pictures prepared for authorities from helicopter flight observations after one overnight

- Limites de secteur
- Accumulations importantes sous forme de galettes et plaques / végétaux pollués
- Accumulations de petite dimension sous forme de boulettes et galettes / végétaux souillés
- Coloration des végétaux, aucune accumulation

Marée : Coef: 83
BM : 13h07 / PM : 18h25

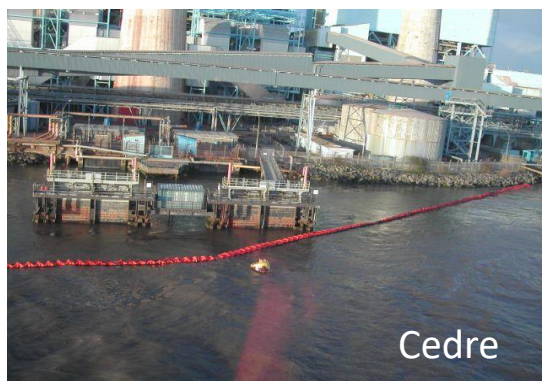
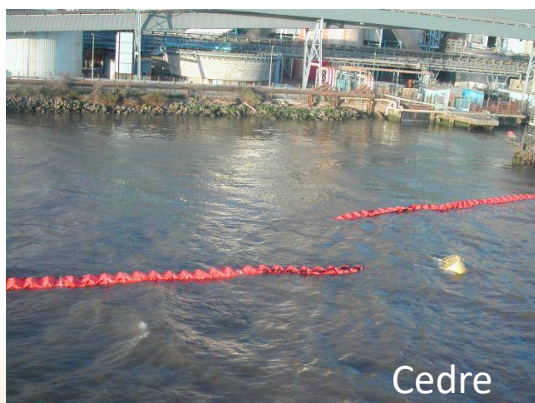
- Try to protect sensitive areas and strategic resources in the estuary
- Anchoring difficulties
- Strong currents
 - As expected, limited efficiency

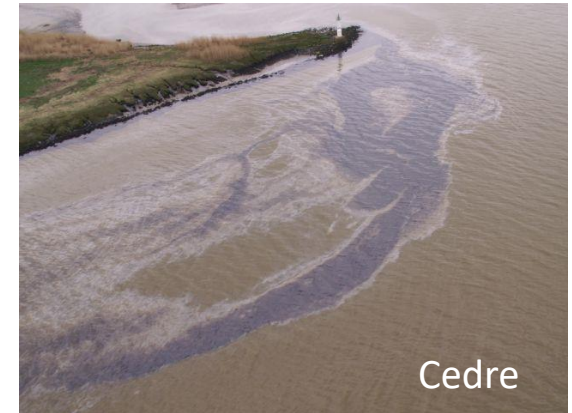
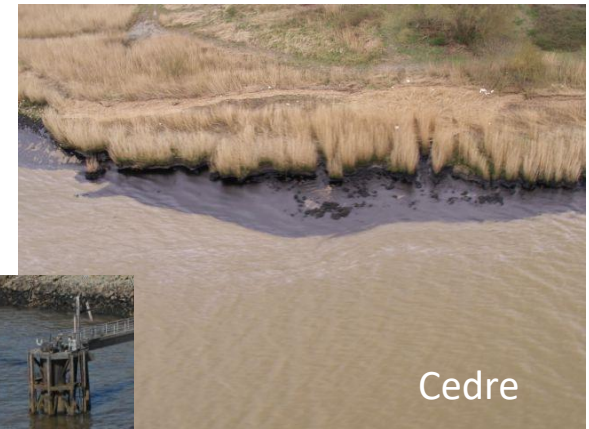
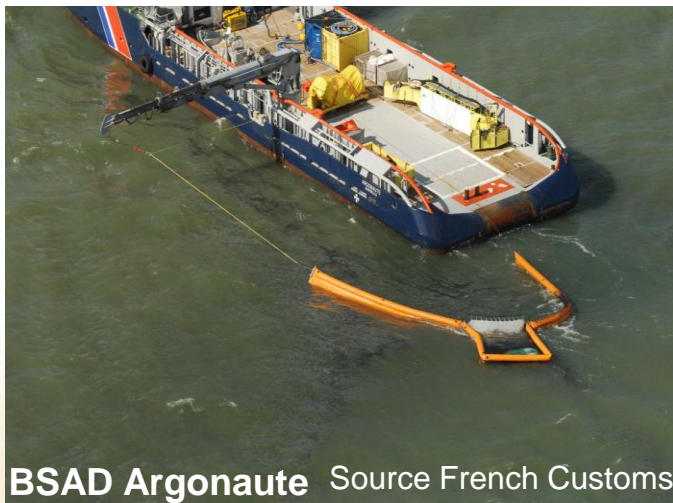
- Due to neap tides oil remains on water and on low part of the banks or in shallow water
 - *Oil spill Response vessel Argonaute* was tested with *Thomsea* trawlnet (too large vessel, and fluid oil)
 - Then mobilisation of fishing boats
 - Small skimming barges suited for shallow waters were not available
- **Low quantity of oil recovered**

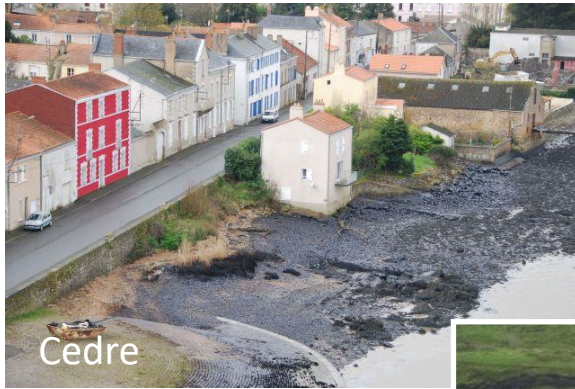
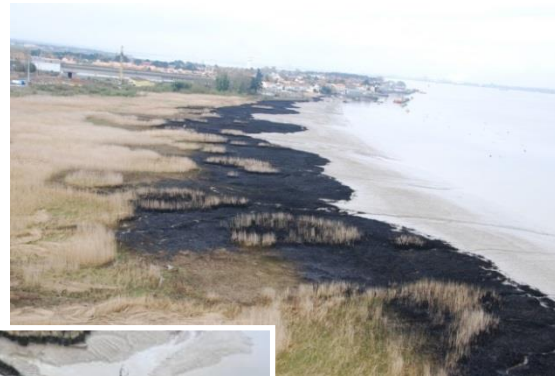
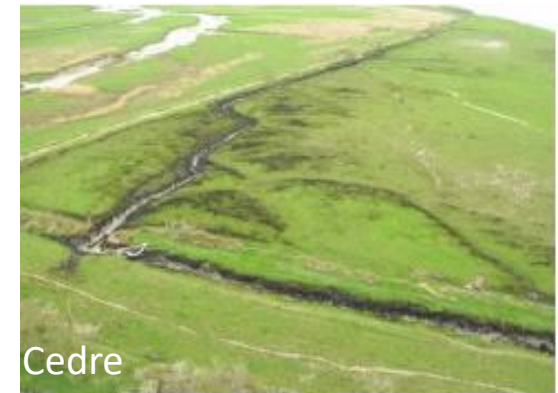
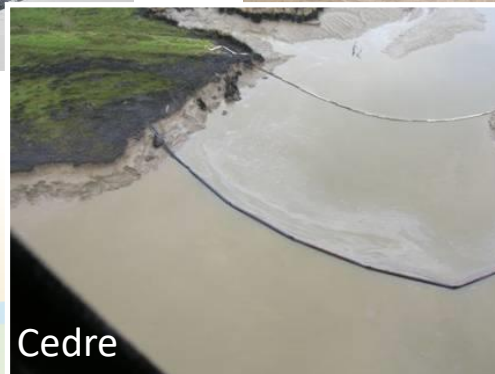
- At high tide, sudden spillover the banks, large extension of contamination
- Oil contaminates new areas,
- Oil penetrates into small creeks and overflows spreading into meadows and wetlands

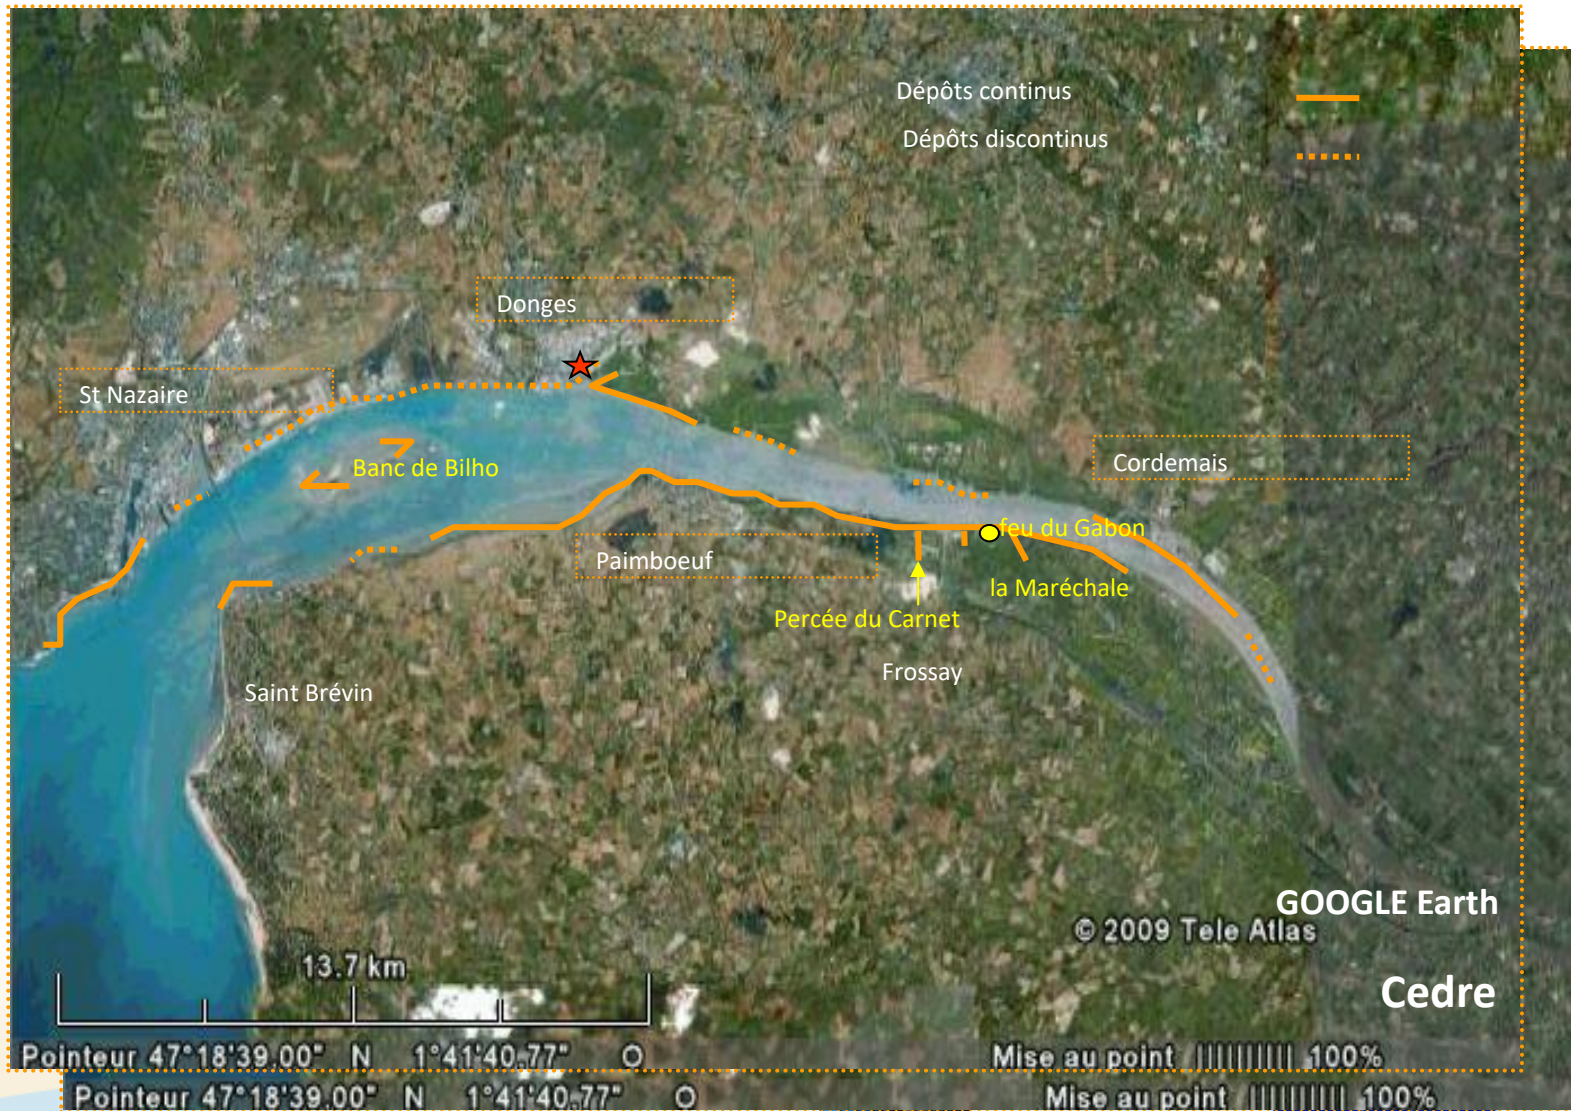
6 days after the spill, the contamination reaches almost its maximum extension in width and length (32 km)

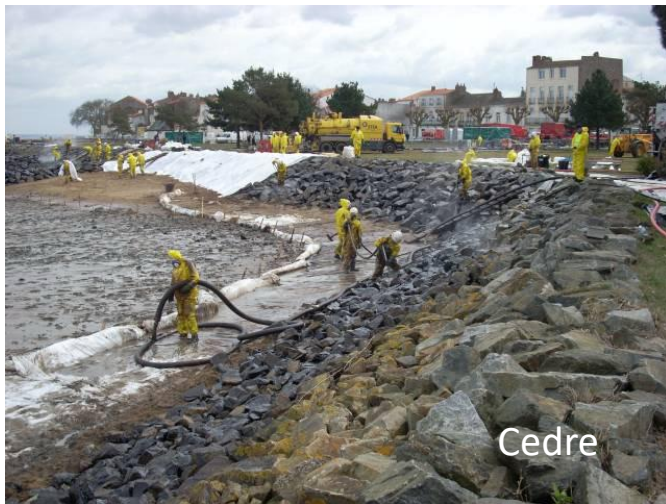
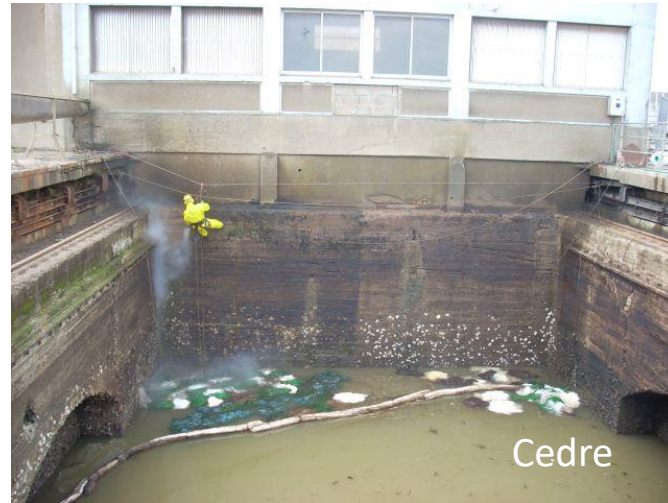
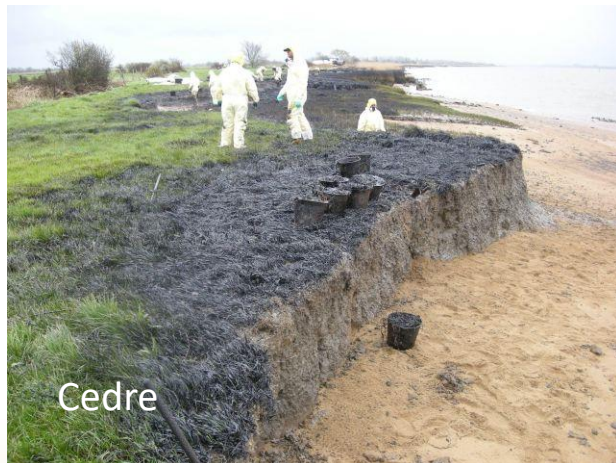
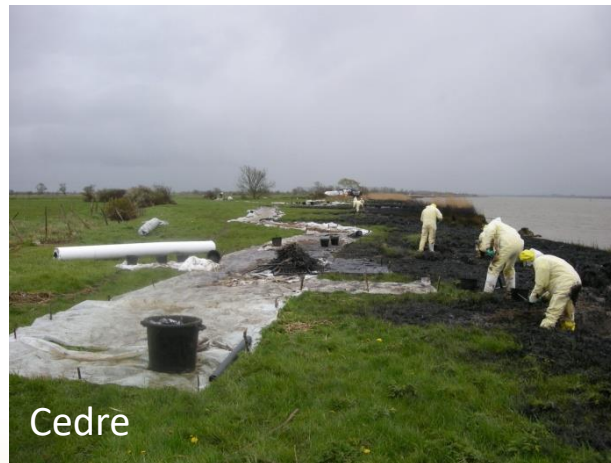
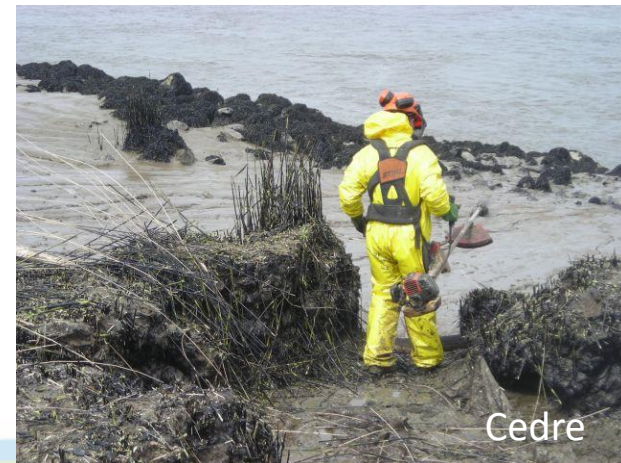
As a result : 3 months of cleanup operations, 25 000 man day

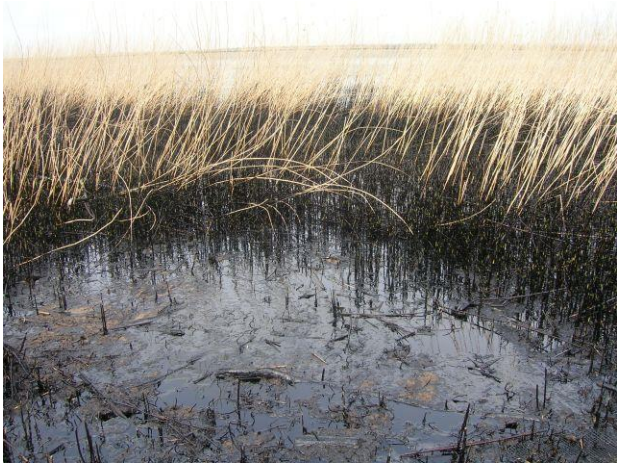
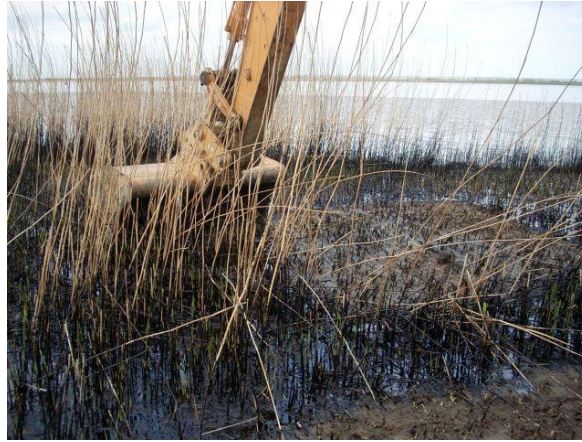
Reeds heavily oiled, use of mechanical equipment

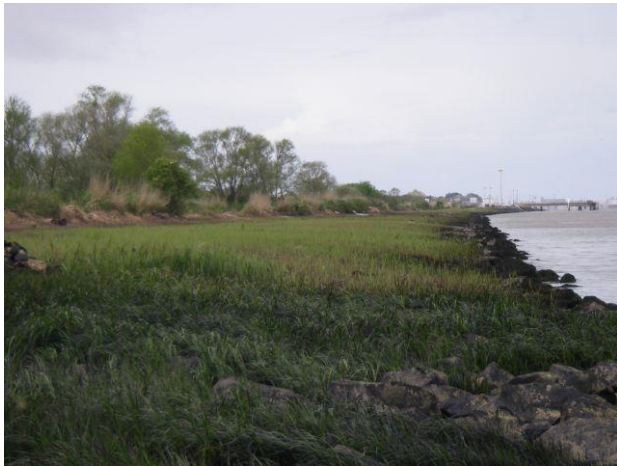
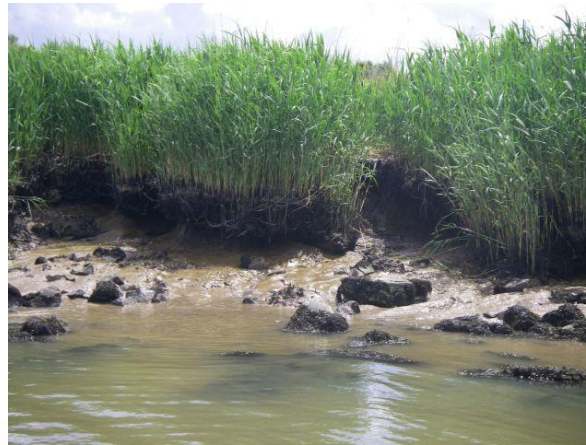
1 month after

few weeks to one year no more impact measurable

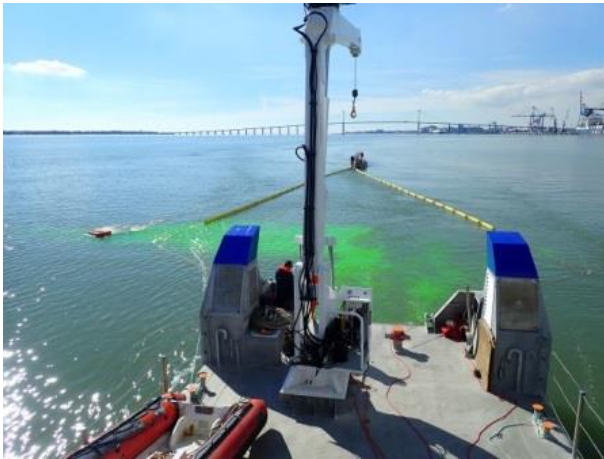
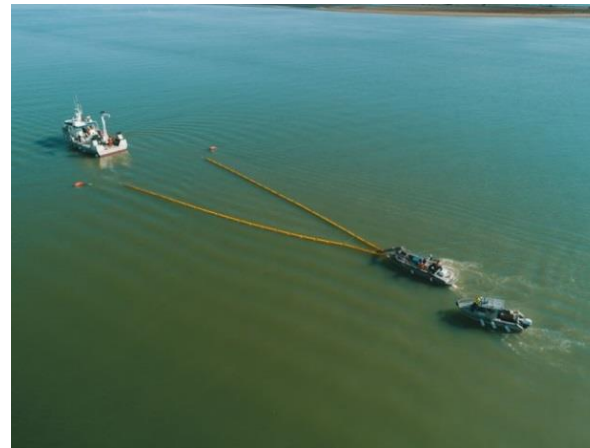
Elastec rapid response system (R3S) can afford current of 3 to 4 knots deployed by the *Bonne Anse* ship of Phares et Balises of Saint-Nazaire

- Model improvement (French authorities, Hazrunoff project) and faster transmission of observations and model forecast (Hazrunoff platform)
- New tools as UAV (SDIS44, and test in the frame of Hazrunoff project)
- Better adapted equipment for recovery in fast currents : since 2013 Cedre organise with the GPMSN, Phare et balises and manufacturers tests of new equipment in the Loire estuary, and in 2018 in the frame of the project

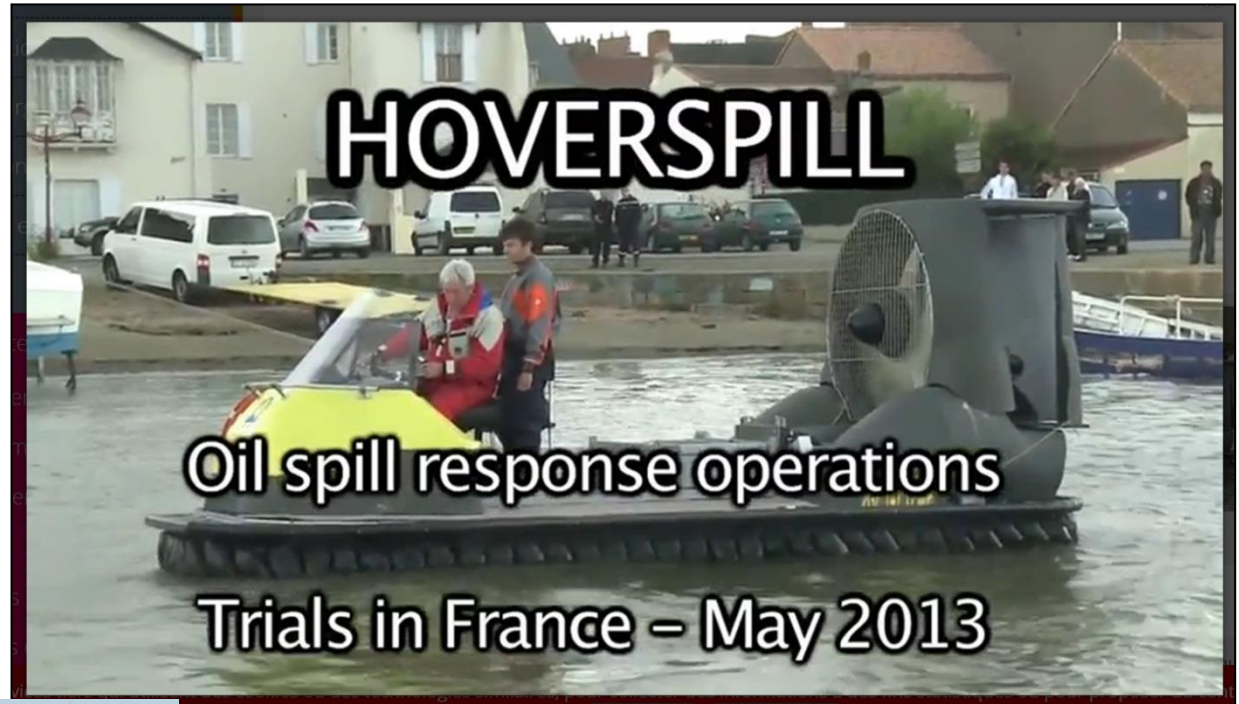
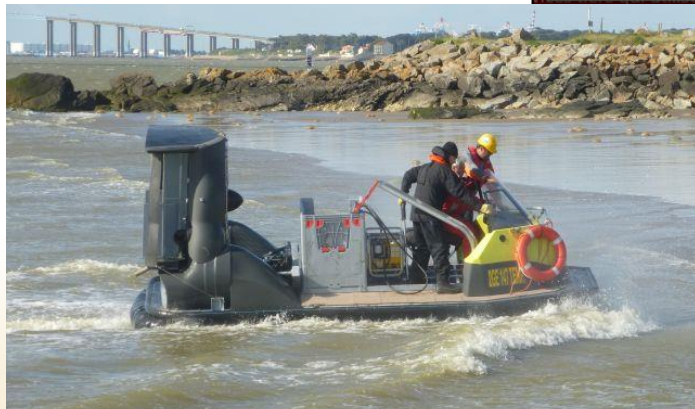
Prototype of hovercraft for operations on mudflats and in shallow waters developed by Italian partners in the framework of a European project

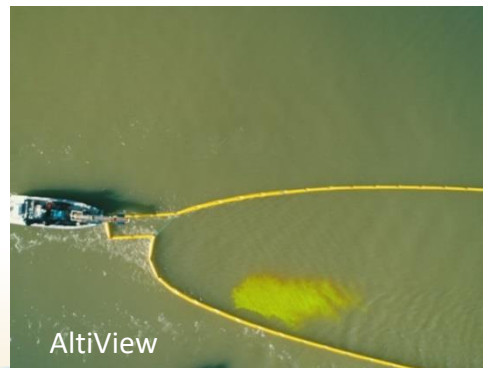
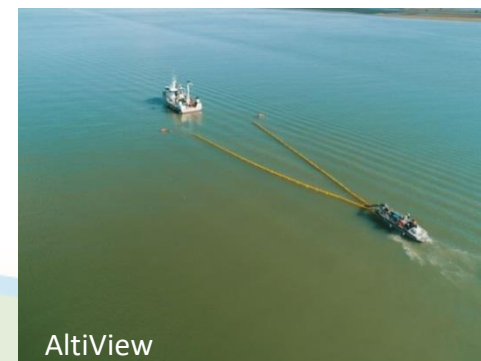
- Slick detection and follow up / fast transmission of alert to the Command centre (HazrunOff project test)
 - Optique (oil)
 - multispectral sensors for HNS soluble in water (in development)
- Support to recovery operations (for recovery boats positioning towards slicks)
- Mapping of oil extension ashore or in flooded areas of difficult access

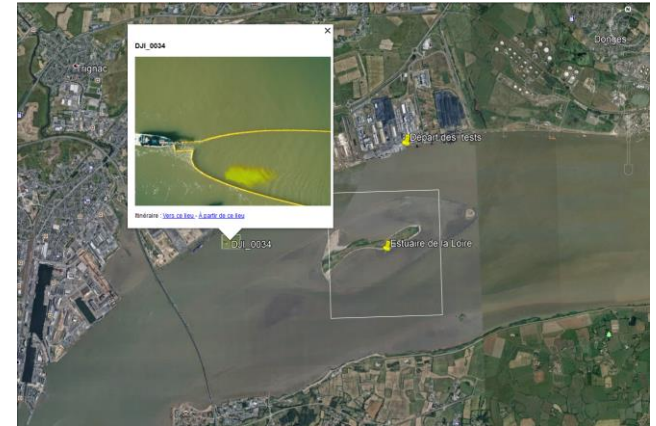
Positioning of the slick in the Loire estuary, using Geosetter/Google earth, for fast forwarding information to the authorities

- Picture export to *GoogleEarth*© (ex : geosetter application)

Allow a fast transmission of slick position
