Integration of sensing and modelling technologies for early detection and follow-up of hazmat and flood hazards in transitional and coastal waters

Learning from past incidents; preparing for the future Florence Poncet, Stéphane Le Floch CEDRE

Feed back on past accidents Oil spill in the Loire estuary (France) from a pipeline in an oil refinery

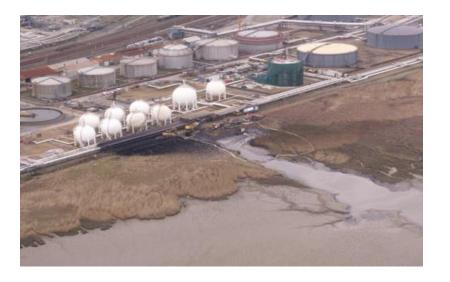
500 tons of intermediate fuel oil spilled (IFO 380), 200 t

Oil extension in the estuary : 32 km

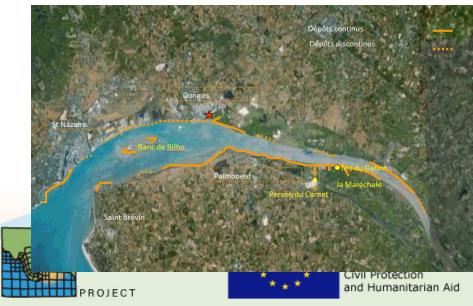
Available model for oil slick drift forecast in the estuary

- Hydrodynamic model : 3 to 4 days were needed to run the model and get results
- In the Contingency Plan : trajectory simulations were prepared in advance
 - Four scenario were chosen (48 maps with different hypothesis of wind, currents and tide)
 - Model results compared to 3 floaters trajectories dropped in the estuary
- A synthetic map was elaborated which shows the extreme points reached by the oil in the estuary (global results were OK)

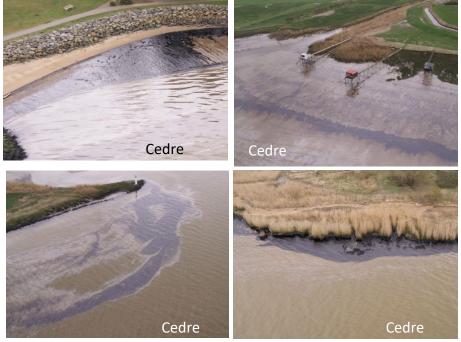
Evolution of oiling conditions

Due to neap tide and river flow, oil remains on water and on low part of the banks

Water overflow in the floodplain (4 000 ha of marshes and meadows submerged and potentially contaminated) Oil penetrates into small creeks and overflows spreading oil into meadows and wetlands

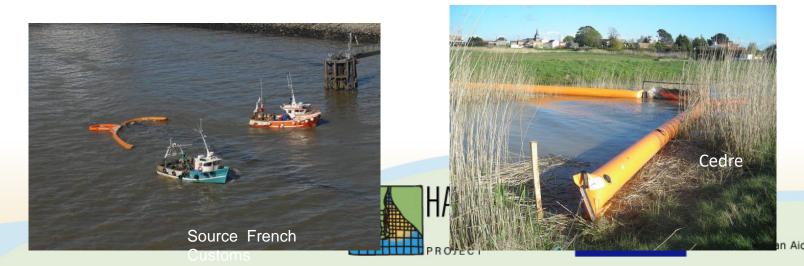
Response operations : recovery of floating oil

Very short time opportunity : floating oil only during 4 days :

- Navy OSRV Argonaute (with Thomsea trawInet)
- Mobilisation of small fishing boats
- Moored Thomsea trawl nets in small creeks
- Few skimming barges suited for shallow waters, but none available in the area
 - Most of the floating oil was in very shallow waters close to the banks
 - High currents limited efficiency of booms
 - > Very low quantity recovered

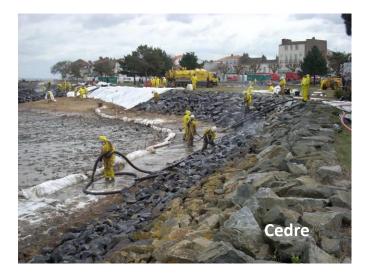
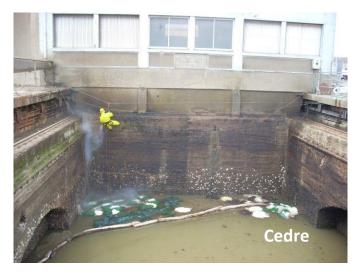
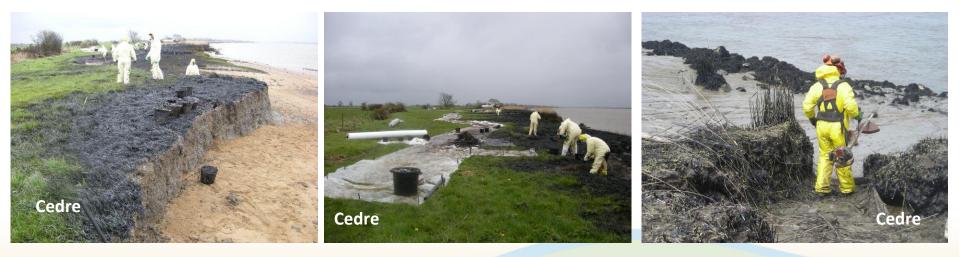
As a result : 3 months of cleanup operations on banks (25 000 man days)

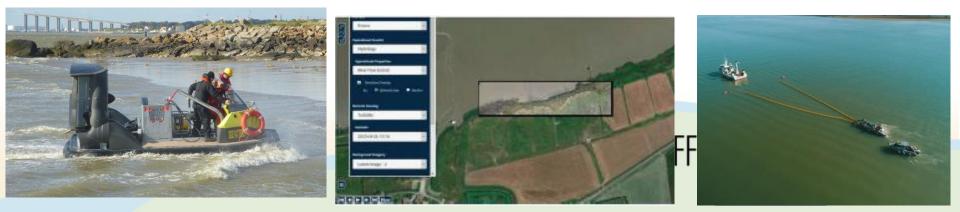
Test of equipment adated to high-currents

Conventional booms are efficient for currents up to 0,35m/s **(0,7 knots)** in perpendicular configuration

example of NOFI « Current buster » efficient up to
4 knots used for dynmamic/static recovery

An open worknet to slow down the current

Towed by 2 vessels

Towed by 1 vessel and a paravane (deflectore)

- Model improvement and faster transmission of forecast results (French authorities and Hazrunoff project);
- New tools as UAV to help oil spill extension assessment (test in the frame of Hazrunoff project);
- **Prototype of hovercraft for operations on mudflats and in shallow waters** was developped by Italian partners in the framework of a European project;
- Better adapted equipments for recovery in fast currents : since 2013 Cedre, partners and manufacturers organise tests of the capabilities of these new equipments in the Loire estuary, with Harbour teams and vessels;

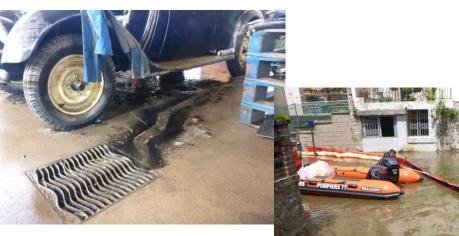
Visible Contamination :

- Domestic fuel oil
- Oils from filling stations
- Used oils from garages
- Wastes, debris

Invisible contamination :

- Phytosanitary, pesticides...
- Chemicals from professional activities (painting, plumbing ect..
- Organic (sanitation systems, liquid manure tanks....)

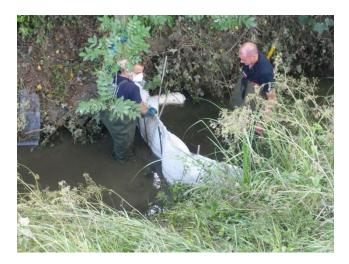
Makeshift solutions : filtration of contaminated waters in river bed or pumped in houses and basements

Makeshift filtration barrier (wire-mesh and loose sorbent)

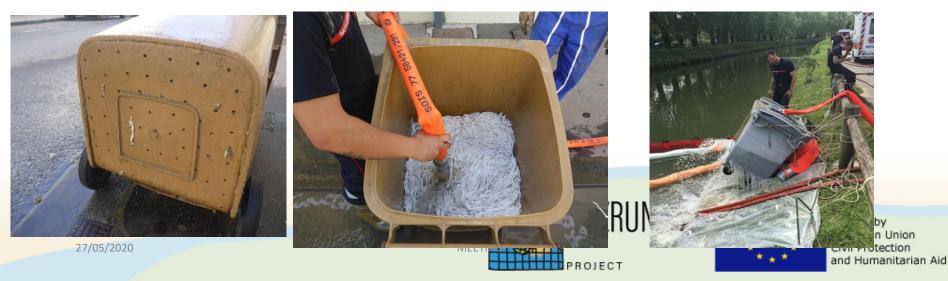
Drilling holes at the bottom of a bin filled with loose-sorbent
